Town of Black Mountain

Public Safety Building Facility Condition Assessment

February 5th, 2026

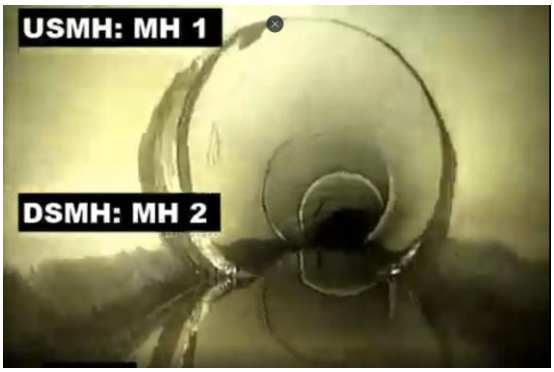
Cracking was observed in the pavement along the east side of the building. Based on the CCTV video, a damaged and cracked pipe is located beneath this pavement and is likely contributing to excess subsurface moisture and resulting ground settlement. Pavement along the south side of the building is generally in good condition and slopes downward from the driveway entrance off Montreat Road toward the driveway connection at West Street. During the site inspection, it was observed that roof drains from the Public Safety Building are located within the sidewalk and daylight at the edge of the sidewalk. Roof runoff from the south side of the building likely drains

east toward the inlet adjacent to West Street. Pavement along the south side of the building, in front of the fire apparatus bays, is concrete, while the remaining pavement throughout the site is asphalt.

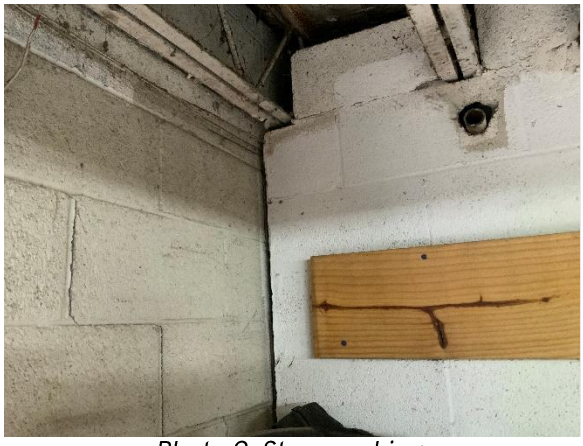
Photo 8: Step cracking.

Many of the perimeter basement walls within the basement footprint were covered up with storage materials making a thorough inspection of all of them difficult. However, at visible areas, primarily along the east wall, vertical and step cracks were visible. Additionally, evidence of the east wall moving away from the building was observed.

Removing continuous strips of floor slabs adjacent to the bottom of the existing retaining walls is not advised for most retaining walls. Normally, basement walls will rely on the slab to restrain the bottom of the walls from sliding. When the slab is removed, this restraint is also removed, and the walls may become unstable.

Because the extents of these soft soils are unknown, it is recommended to perform borings in and around the facility. To get a realistic view of the soils below the building, borings will need to extend below the elevation of the cracked drain line. Moseley should be contacted to locate the borings and a specialty contractor with expertise in providing borings inside a structure should be contacted to gain insights into how this should be completed. It is also recommended to run a camera down the other drains in the facility to determine if any other drains are broken. After completion of this work, please contact Moseley with the results of these findings for further analysis.

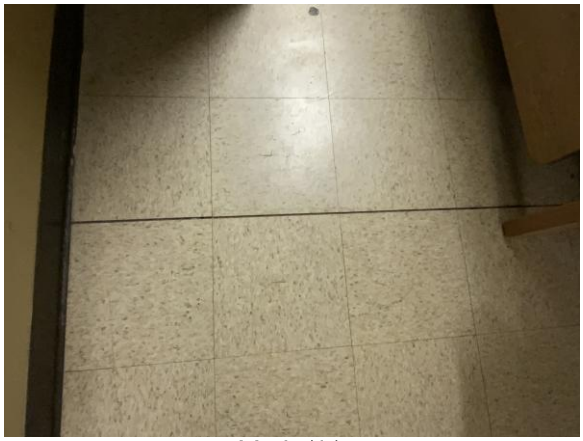
Photo 22: Cracks in wall tile.

length of the building. Additionally, the slab along this entire side of the building has experienced large cracks and differential settlements of up to one inch. Cracking in some of the gypsum covered walls is visible, and walls with brittle finishes, such as the tiled walls in the men's bathroom, are showing many cracks throughout the walls and floor areas. Evidence of the slab settlement is apparent where gaps between the top of the slab and bottom of the cove base is more than 1/2 of an inch. At one location, it appears that the wall ties that are attached to the slab are dragging the slab towards the exterior wall as the veneer moves. Distress due to settlement and reported roof leaks during Hurricane Helene are visible in the ceilings as well.
